**Flood Control Project Maintenance
Levee Inspections**

Fall 2016 Levee Maintenance Deficiency Summary Report

Sacramento River Basin

Reclamation District No. 0307 Lisbon

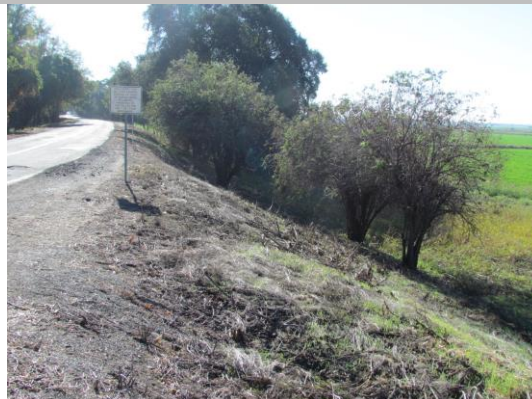
Photo 1 of 1 : FA_2016_RD0307_166_54_20161026_00099.jpg

LM Start	0.05	Rating **	A	Issue No.	54
LM End	3.53	Issue Type +	Ma	Location *	LS
Category	Earthen Levee			GPS Latitude/Longitude	
				Start	End
Item	Vegetation			38.479450 °	38.455925 °
				-121.548897 °	-121.503509 °
DWR ID	DWR_RD0307_01_f_2016_54				
Comment Code					
V1 : Control annual grass and weeds on the levee slopes and easements.					
Inspector Comment					
No unwanted vegetation on landside levee slope from levee miles 0.05-3.53.

RD 307 Levee mile 0.05 looking downstream at the landside levee slope.

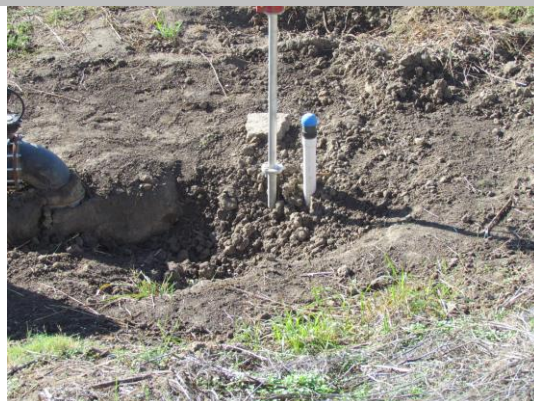
Photo 1 of 1 : FA_2016_RD0307_166_4_20161027_00106.jpg

LM Start	0.58	Rating **	M	Issue No.	4
LM End	0.58	Issue Type +	En	Location *	LS
Category	Earthen Levee			GPS Latitude/Longitude	
				Start	End
Item	Encroachments			38.474533 °	38.474533 °
				-121.541470 °	-121.541468 °
DWR ID	DWR_RD0307_01_f_2014_4				
Comment Code					
EQ : Equipment					
Inspector Comment					
The land owner need to remove the equipment from the landside easement.

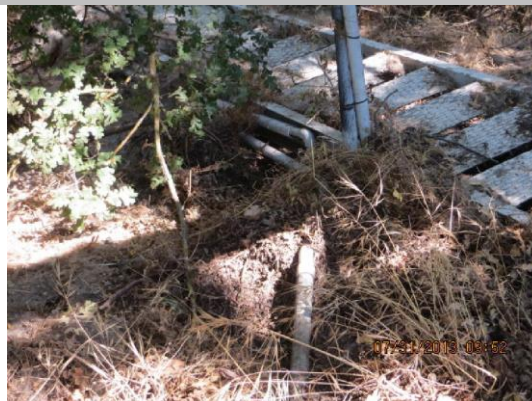
Photo 2 of 2 : UCIP_FA_2016_17105_29206.jpg

Pipes visible on WS shoulder at steel walkway.

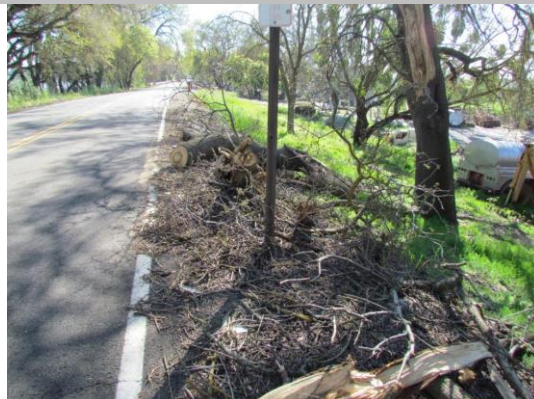
Photo 2 of 3 : FA_2016_RD0307_166_73_20160913_00015.jpg

Looking downstream toward levee mile 1.87 fallen tree on shoulder.

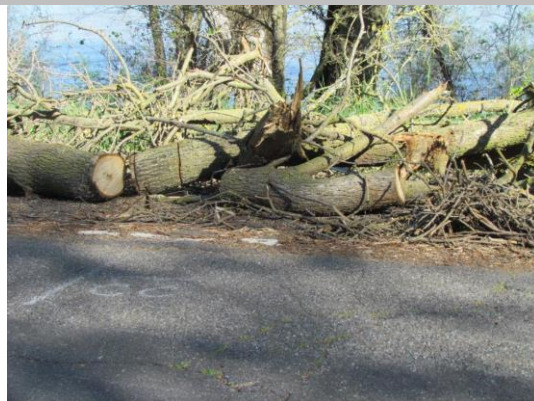
Photo 3 of 3 : FA_2016_RD0307_166_73_20160913_00016.jpg

Waterside shoulder levee mile 1.86 more of the cut up oak.

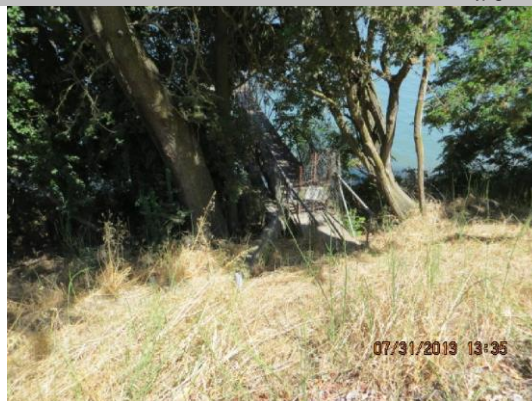
Photo 1 of 2 : UCIP_FA_2016_16924_28982.jpg

Pipe and walkway visible on WS slope.

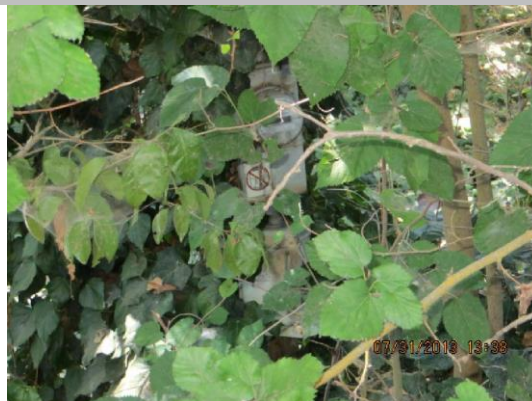
Photo 2 of 2 : UCIP_FA_2016_16925_28983.jpg

JP and meter on LS toe.

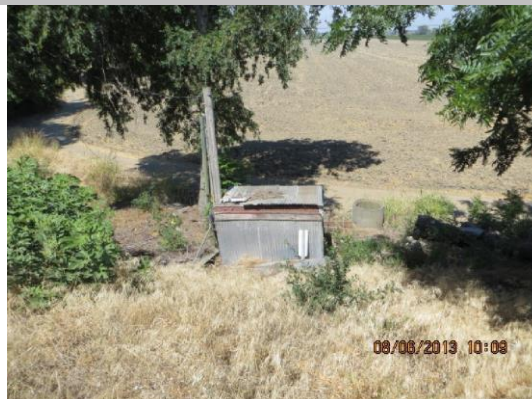
Photo 1 of 2 : UCIP_FA_2016_17183_29321.jpg

Pumphouse for 6-inch pipe at LS toe.

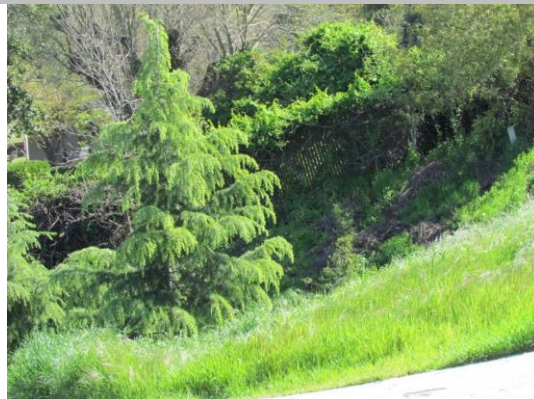
Photo 2 of 5 : FA_2016_RD0307_166_28_20160913_00010.jpg

Looking upstream landside slope and toe trees planted on the levee section.

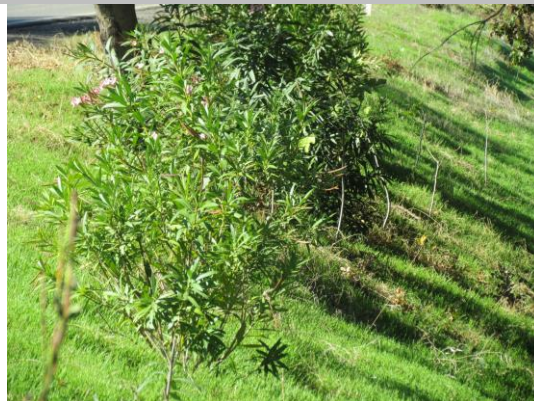
Photo 3 of 5 : FA_2016_RD0307_166_28_20161027_00102.jpg

RD 307 Landside looking downstream top of slope, unauthorized planting of young oleanders and young fig trees.

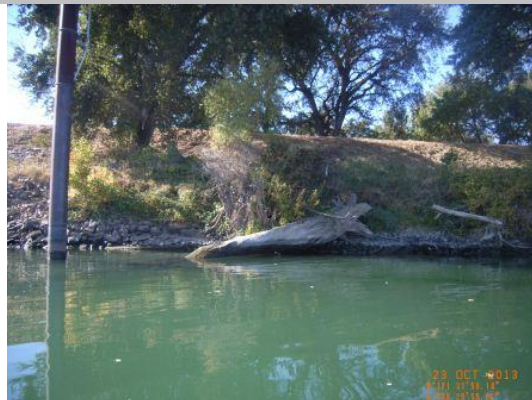
Photo 1 of 1 : FA_2016_RD0307_166_2_20160913_00002.jpg

LM Start	6.19	Rating **	M	Issue No.	2	
LM End	6.38	Issue Type +	Ma	Location *	WS	
Category	Supplemental			GPS Latitude/Longitude		
				Start	End	
Item	2015 USACE Erosion Survey, DRAFT			38.434560	° 38.432287	
				-121.531159	° -121.532978	
DWR ID	DWR_RD0307_01_s_2016_2					
Comment Code						
Inspector Comment						
2008 - Large rotational failure in bank and well into the levee slope. Could be a significant problem in the next high flow event. 2009 - Minimal new erosion, site extended upstream. 2010 - Minor new erosion. 2011 - Tree popout has left a large hole. Large slump area. Rock on the bank is failing in some locations. 2012 - The toe appears to be scouring out. 2015: No observed changes. [2015 Site ID: SAC_43-2 R]

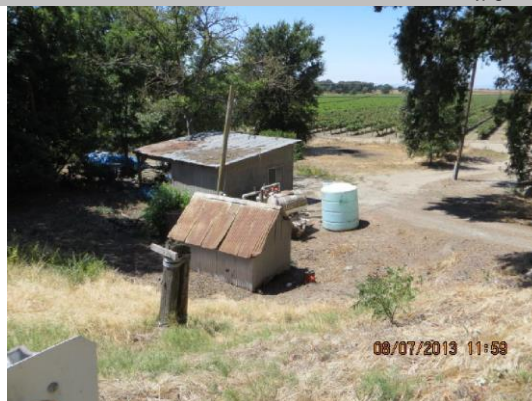
Photo 1 of 2 : UCIP_FA_2016_17385_29489.jpg

Pump and gate valve inside pumphouse on LS toe.

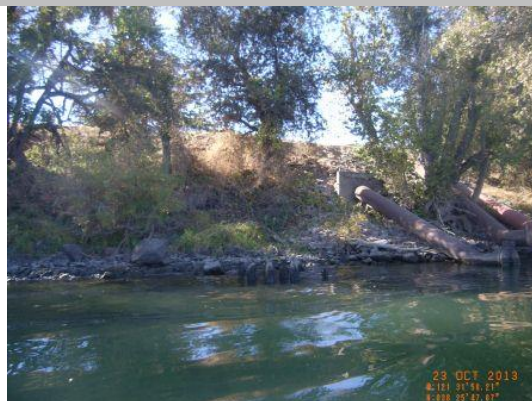
Photo 1 of 1 : FA_2016_RD0307_166_8_20160913_00004.jpg

LM Start	6.42	Rating **	M	Issue No.	8
LM End	6.55	Issue Type +	Ma	Location *	WS
Category	Supplemental			GPS Latitude/Longitude	
				Start	End
Item	2015 USACE Erosion Survey, DRAFT			38.431726 °	38.429957 °
				-121.533200 °	-121.533035 °
DWR ID	DWR_RD0307_01_s_2016_8				
Comment Code					
Inspector Comment					
2011 - Erosion pockets likely from tree popouts. This site has been in the inventory before and been fixed with emergency bank rock but continues to fail. 2015: No observed changes. [2015 Site ID: SAC_43-1_R]
